Garden Plaza @Cyberjaya

The Proposed Design and Build Retaining System on Existing Cut Slope

(by Jeremy Lim Wei, Assistant Project Manager) (2012 Jan-Mar)

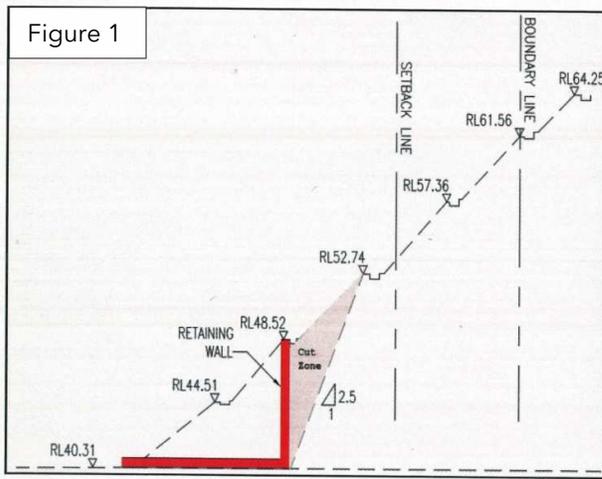
The toughest yet challenging part of this job is the northern side of basement wall boundary situated along the second berm of existing cut slope (i.e. Done by others as Photos 1). In order to facilitate the construction of the basement wall and foundation pile along the slope (refers Figure 1), a temporary retaining system is required to stabilize this temporary cut slope. A few options of the temporary retaining system have been considered, such as contiguous bored pile wall, soldier pile wall or soil nail with shotcrete option. As

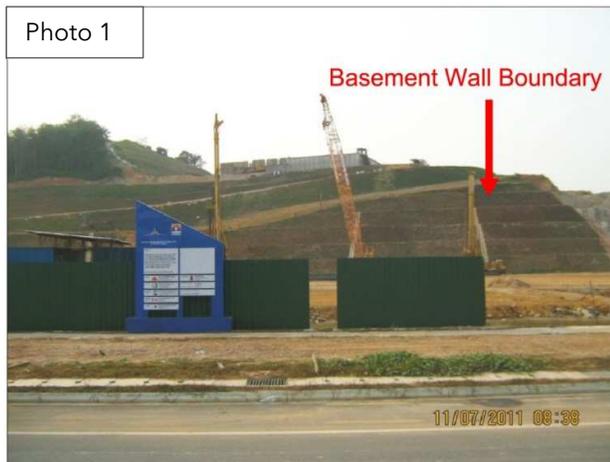
In considering of high cohesive hard soil material and coupled with low groundwater table, the final option being adopted is by forming temporary open cut slope of 2.5V:1.0H to facilitate the construction of 7.6m height basement wall. Overall slope stability for the cut slope was checked and analysed, the factor of safety was able to attain more than 1.2 for temporary slope requirement. However, the critical slip cycle was detected on the shallow slip of slope surface. In order to arrest this concern and improve the stability, a thin layer of 50mm shotcrete was immediately sprayed on freshly cut slope face and reinforced with a layer of BRC (Photo 2). The main purpose is to maintain the soil suction developed after cutting and preventing it from dissipated due to long exposure to surface runoff, thus it improves the temporary stability of shallow slip surface on the exposed slope. During the cutting of the

slope, the exposed cut surface was noticeably remains dry and consists of medium to stiff soil and highly weathered sandstone, with no groundwater was encountered.

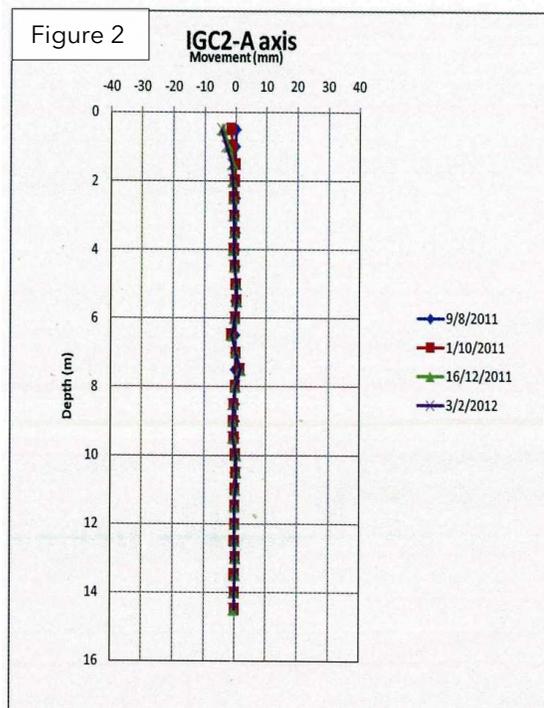
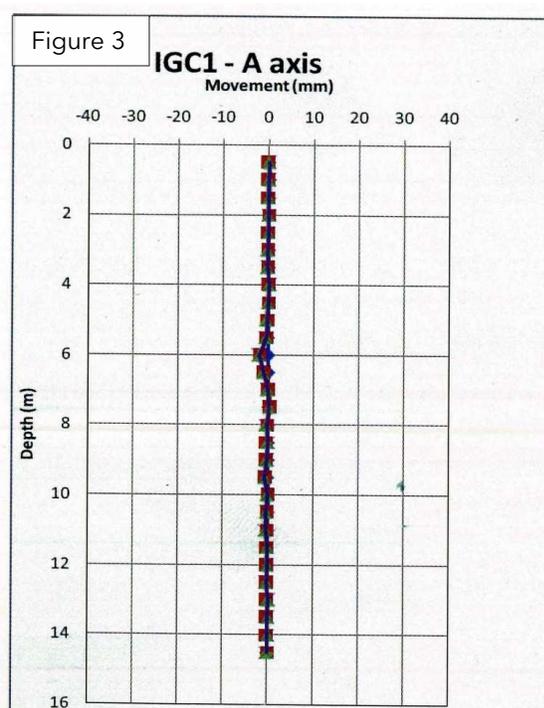
As a prudent approach, a well-planned monitoring scheme by having two inclinometers at top of slope is implemented to monitor/detect any creep slope movement. Phew! Over past six months, the inclinometers results (i.e. Axis away from slope) show negligible movements (Figure 2 & 3). With this option, the basement wall could be constructed in most cost-effective manner and eventually giving cost and time saving to the client as well. Thanks to the team members for sheer hard work and determination to make this project a success.
