New Cable Car System @Genting

The challenges and solutions on New Cable Car System at Genting

(by Mr.Jeremy Loh Kwan Yew, DGM-Contracts) (2016 Jan-Mar)

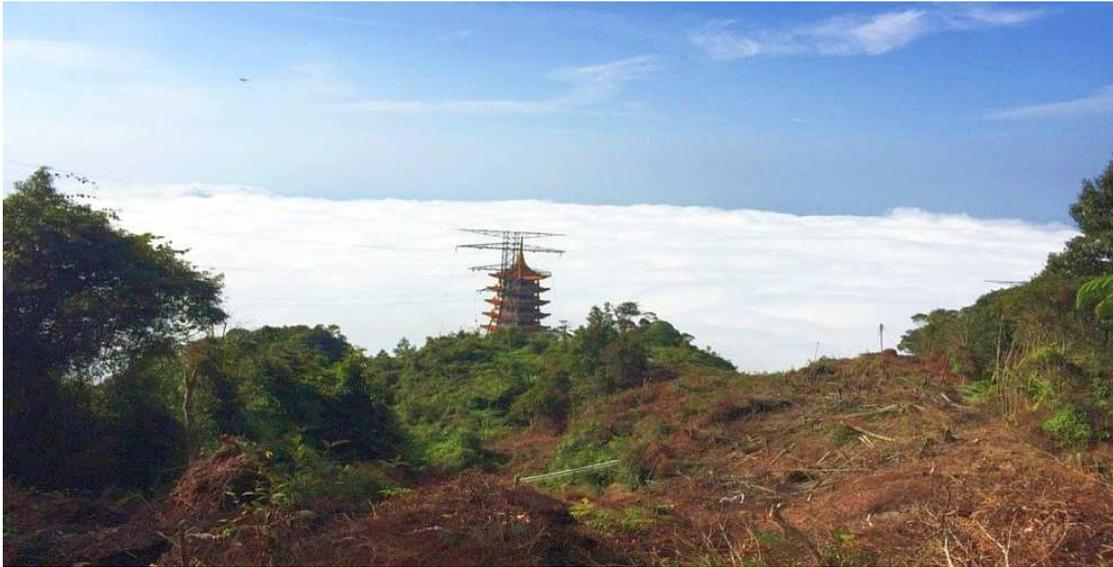
Photo taken during construction stage

Next in our way was the difficult terrain that surrounded us for the construction of the pylons. The pylon locations were not accessible for the use of mobile cranes and other heavy equipments, thus all hoisting and concreting works are carried out by manual labour only. Therefore, temporary pathway and concrete chute were used extensively to facilitate the construction works of the caisson piles for the pylon foundations.

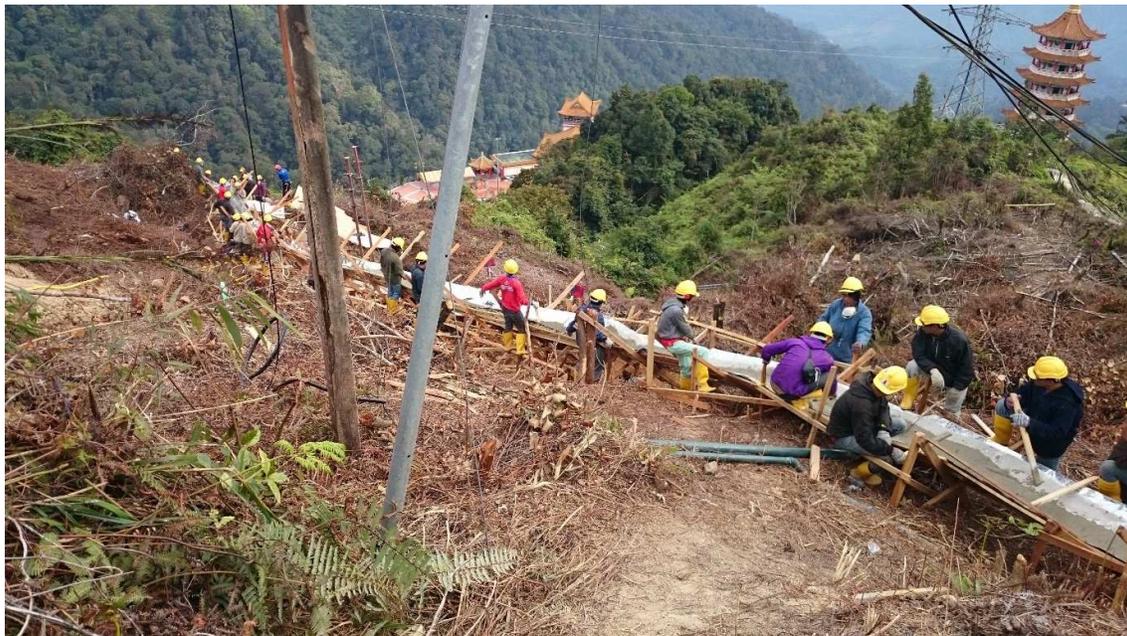
Temporary Concrete Chute

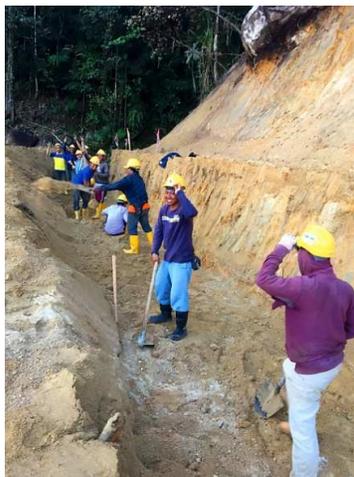
Excavation of Trench

Another challenge that we've encountered in carrying out earthworks in Station 2 was the diversion of a natural water course which was more like a stream formed through decades of rain water gushing and gully through the underlying rocky surface and boulder deposits of valley. It took more than 8 weeks to make progress as the works involved hacking and breaking a large quantum of existing boulders. Besides, there were many voids/cavities needed to

be filled with mass concrete to stabilised the overhanging rocks and the excavation of the trench final levels to receive the new monsoon drains, and mostly all were executed by manual labour as excavators are inaccessible to many parts of the area. It was difficult and challenging as the weather was not on our side when the concreting works began. There were occasions where our effort went futile when fresh placed concrete sections were washed away by 3 consecutive heavy rain-days. The hard works paid off finally, and the permanent monsoon drain worked out fine in a stormy weather 2 days after the last section of the concrete was place.

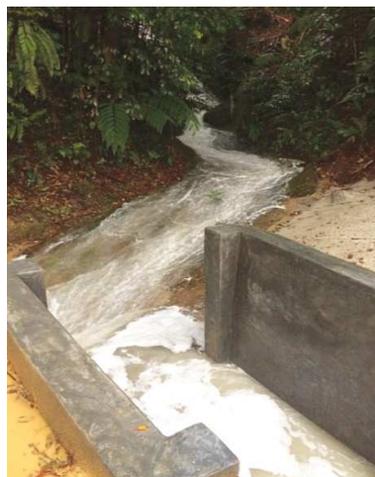
Completed Trench

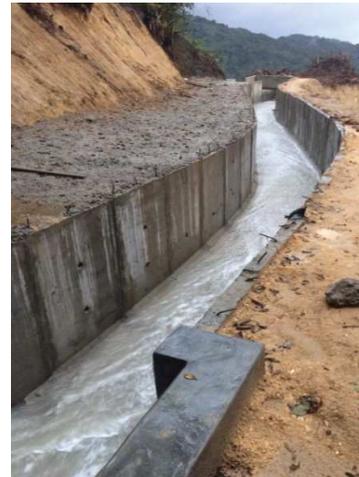
Completed Trench

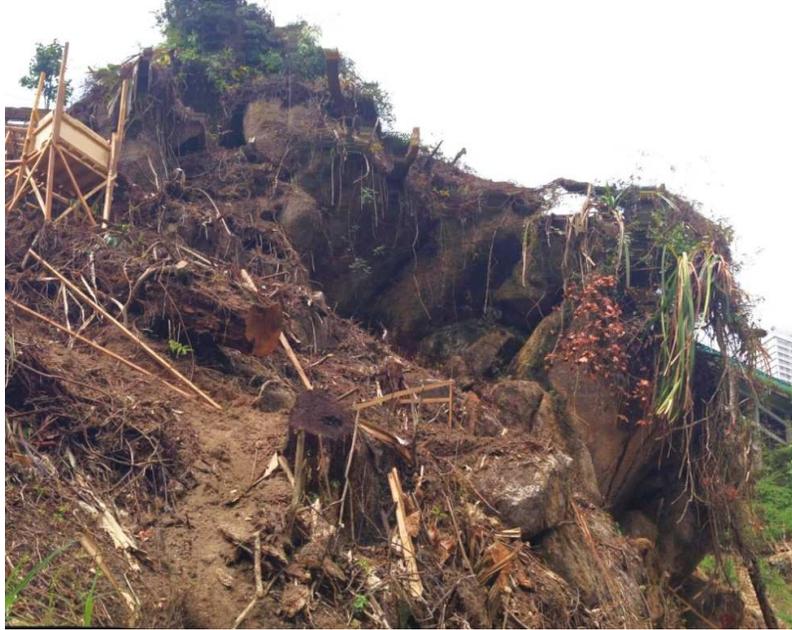
Cluster of Massive Boulder Below Station 3

In station 3, the biggest challenge was to build the entire station above the cluster of gigantic boulders sitting directly below it and there were tough times getting over and around to get the sweet spot for the caisson piles to set foot. However, the inevitable is still inevitable as we couldn't blast or break any of the massive boulders which could trigger rock falls thereby endangering the safety of traffic users of the public road below. In view of such circumstances, the Foundation Engineers had decided to accommodate their design in

consideration of such scenario by introducing transfer beams and adjustment of structural frame to achieve the desired building footprint. This would not be achievable without the essential input of survey data and other constructional information flow in order to get the best design solution.

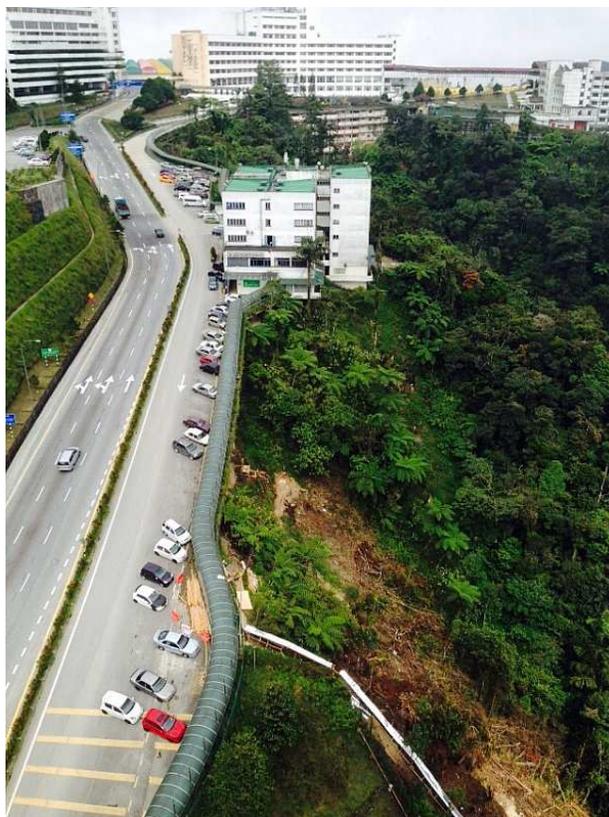
Station 3 on slope

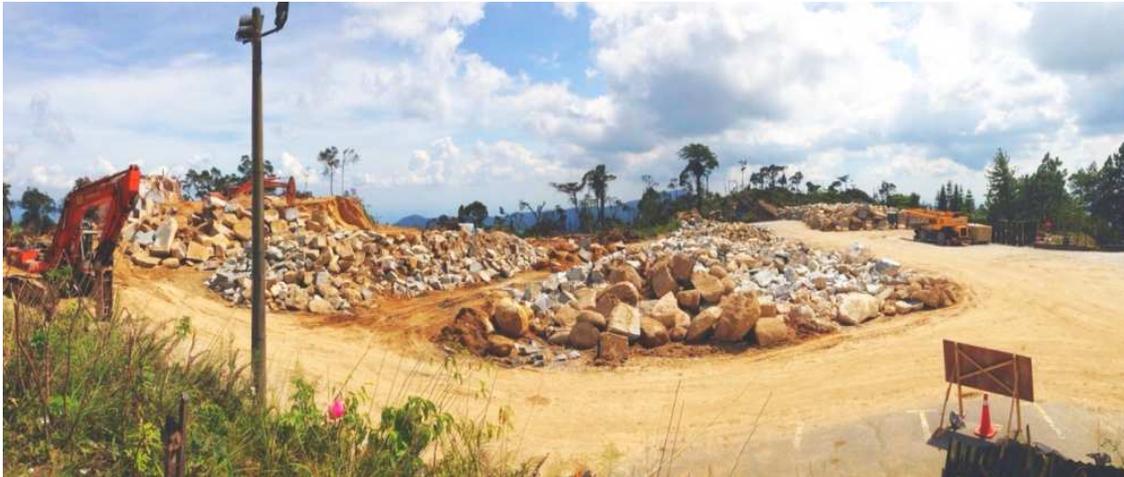
Plant and machineries were deployed to break down the boulders into smaller fragments before they were practicable to be transported out to designated dump site.

Apart from the above, breaking and removal of tons and tons of boulders to make way for development was a huge challenge in terms of time and costs as it involved double or triple handling works. Extra than ordinary numbers of plant and machineries were deployed to break down the boulders into smaller fragments before they were practicable to be transported out to designated dump site.
